Document type
TAC/21019/Final BIA/RT03

Date
March 30, 2022

WOODLANDS WAFER FAB PARK LAND PREPARATION WORKS

Final Biodiversity Impact Assessment Report

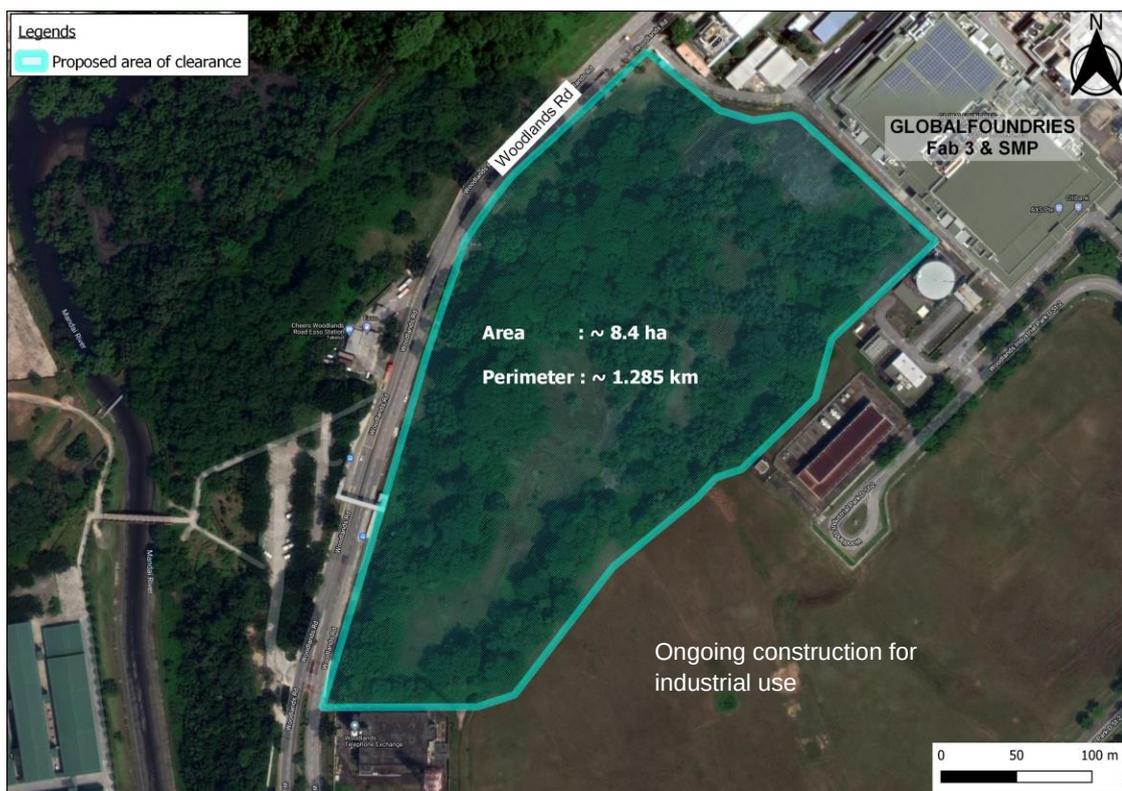
Figure 2.10. Proposed area for tree-felling

Figure 2.10 shows the satellite image of the area where tree-felling will be conducted to clear the land.

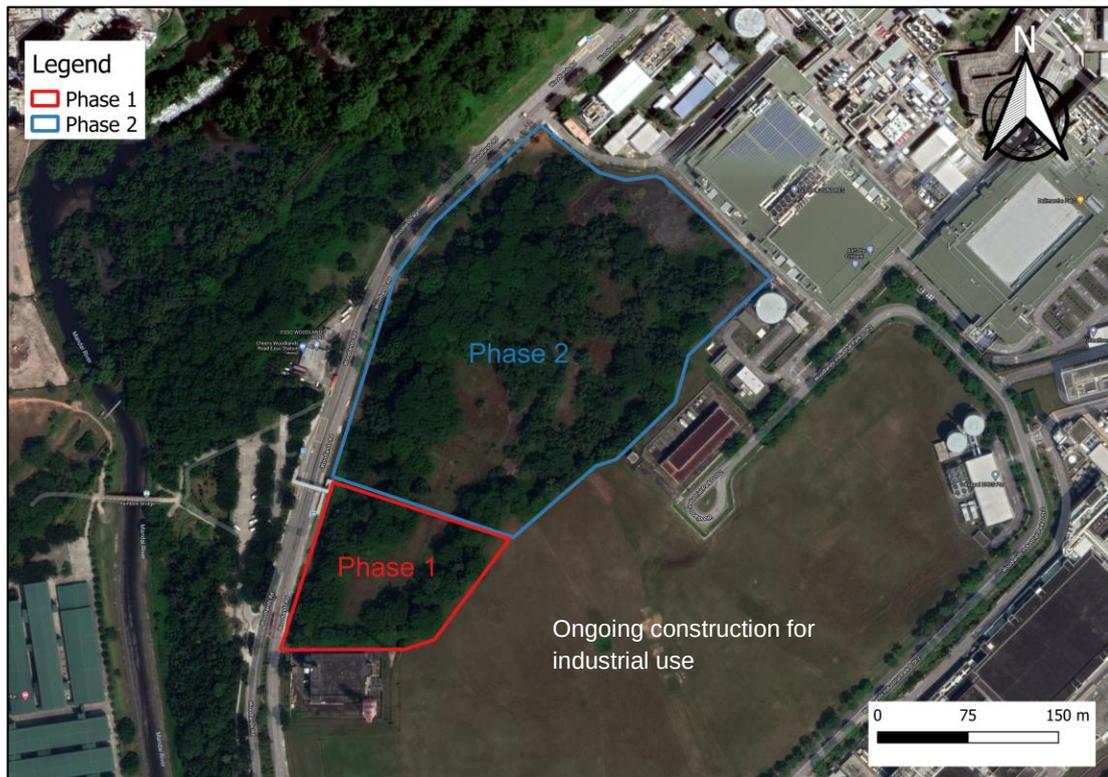
Figure 2.11. Phase 1 and Phase 2 of Hoarding plan

The site works are targeted to commence from 3Q 2022, implemented in two phases, and complete in 1Q 2023 (Figure 2.11). Tree felling works are targeted to commence from August 2022.

- The sequence of works for the land clearance works in this development is as follows:
- Erection of hoarding commencing from southeast boundary and towards northwest boundary (Woodlands Road).
 - Construction of perimeter drains.
 - Felling of trees within the site.

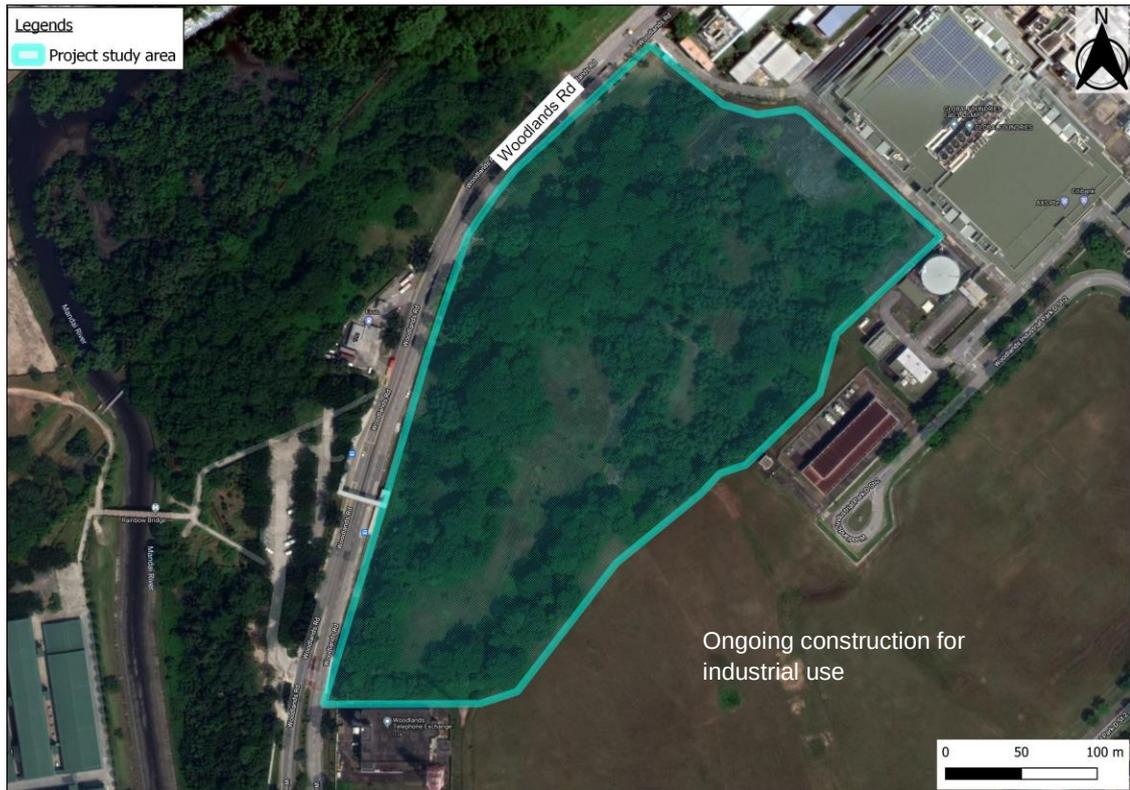
Figure 3.1. Extent of project study area

The BIA study area denotes the area where land clearance activities are predicted to have impacts on various environmental aspects within the site. For this project, the study area covers the entirety of area proposed to be cleared as can be seen in Figure 3.1.

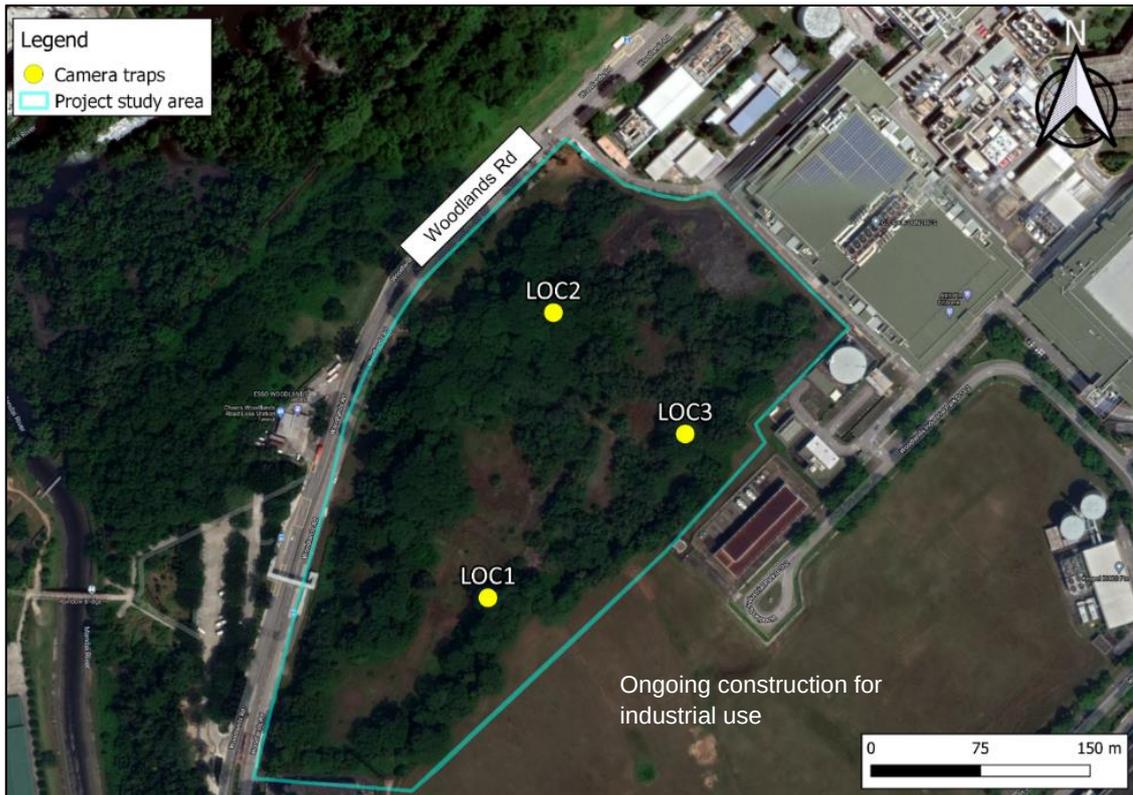
Figure 4.4. Location of the camera traps within the project study area

Three camera traps were deployed throughout the study area from 31 March to 12 May 2021 (see Table 4.5 for GPS coordinates and Figure 4.4 for their location on the map). These remotely activated cameras were equipped with infrared sensors that could be triggered by animal movements. Camera trapping is particularly useful for elusive or rare animals that are not often observed during visual encounter surveys. They also allow for 24-hour monitoring of the study site. The cameras used in this study take colour photos during the day and black and white photos at night using an infrared flash; the use of the latter avoids the problem of blinding or spooking the animals.

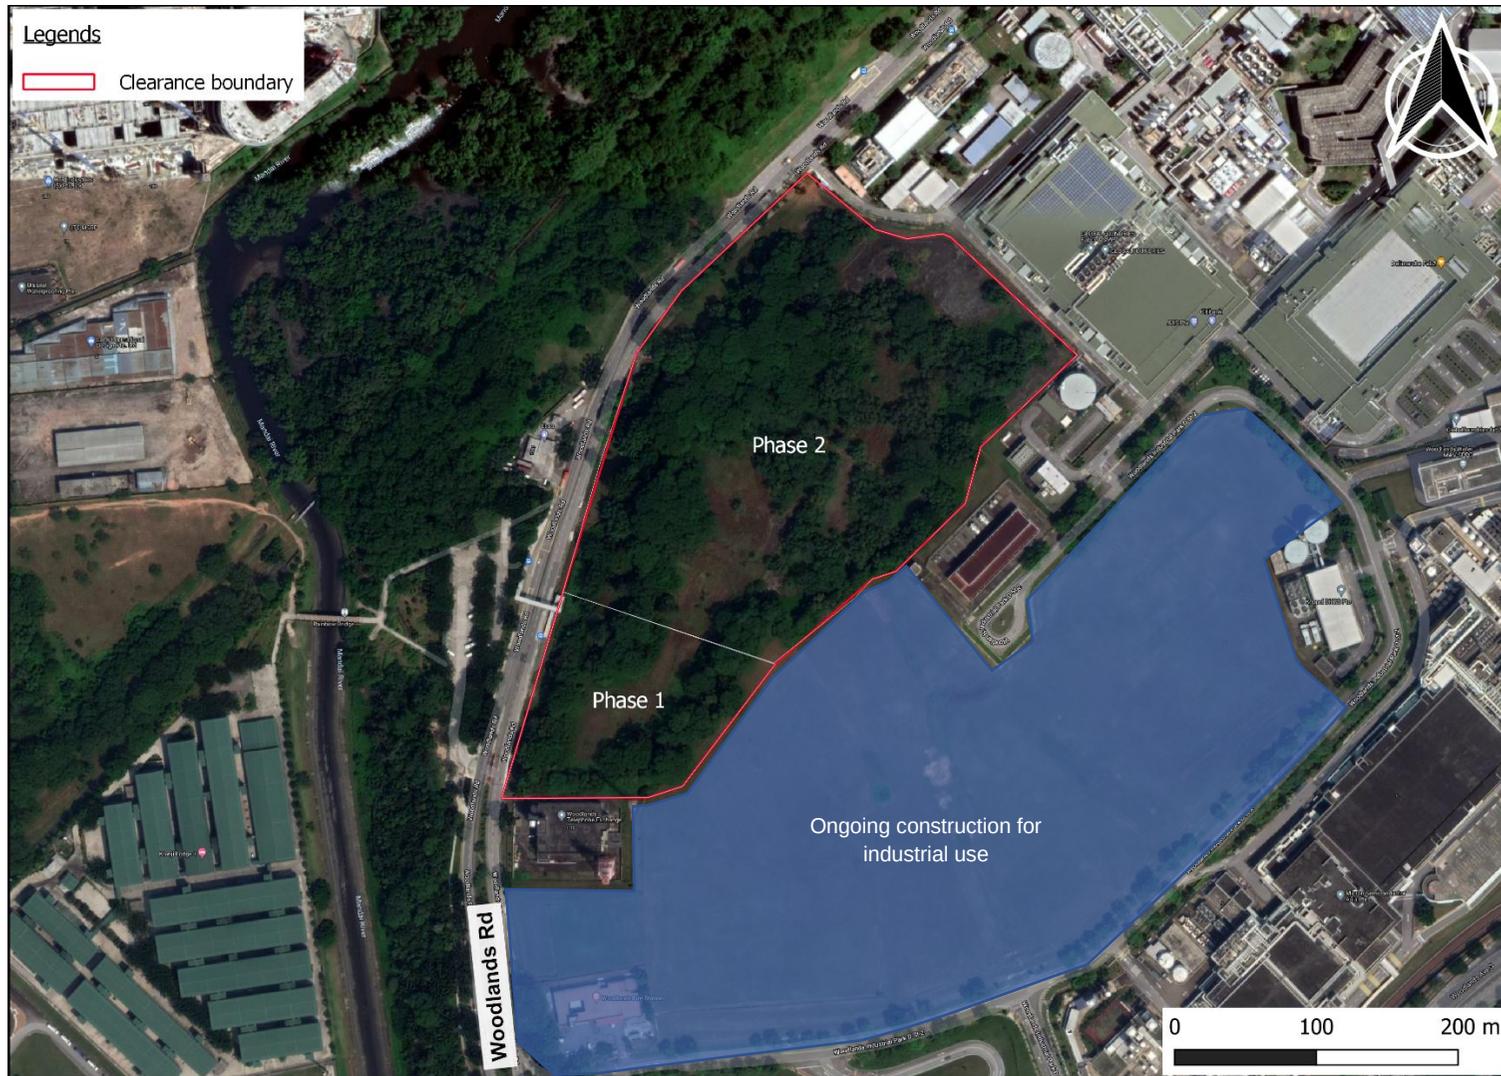
Figure 5.1. Directional Clearance 1

Land clearance would be conducted in two phases, with the respective area for each indicated in the map.

The below figures illustrate the scheduled phasing for vegetation clearance. These activities should take place during daylight hours only (i.e., 8 am to 6 pm) and a minimum of one rest day (i.e., Sunday) per week shall be provided to reduce disturbance to wildlife. Tree felling may commence once understory vegetation has been cleared.

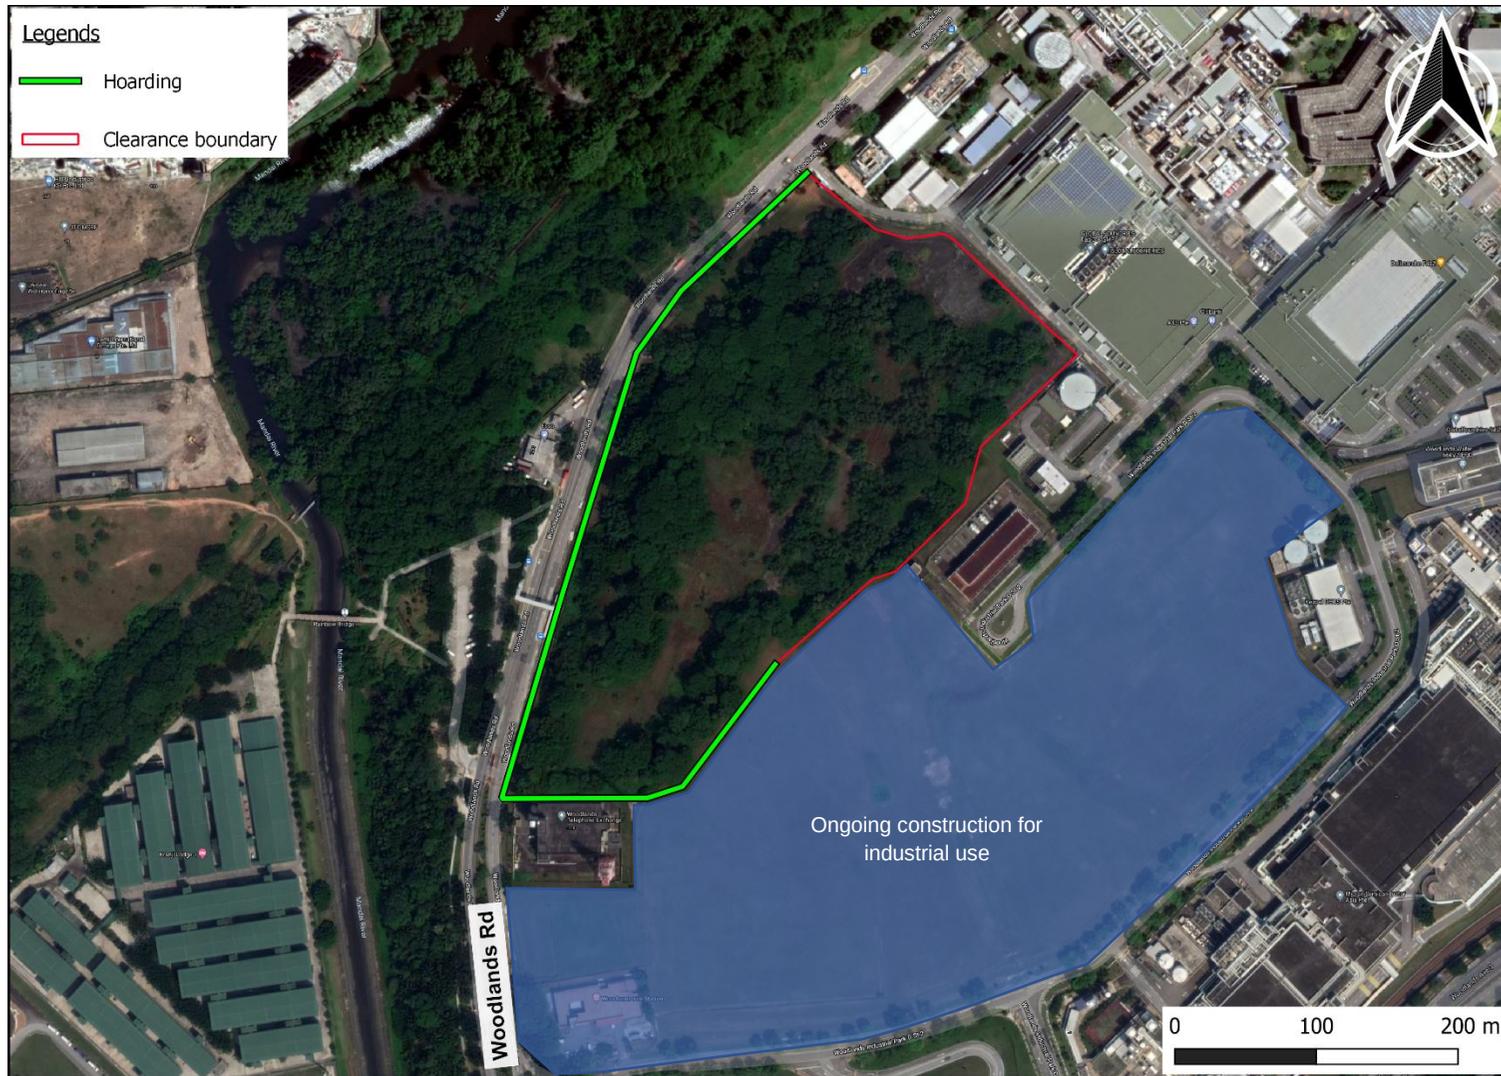
Figure 5.2. Directional Clearance 2

Hoarding for the Phase 1 clearance is to be erected along Woodlands Road, continuing southward before turning eastward and terminate at Phase 1 clearance boundary to prevent animals from running out into the open areas, especially Woodlands Road.

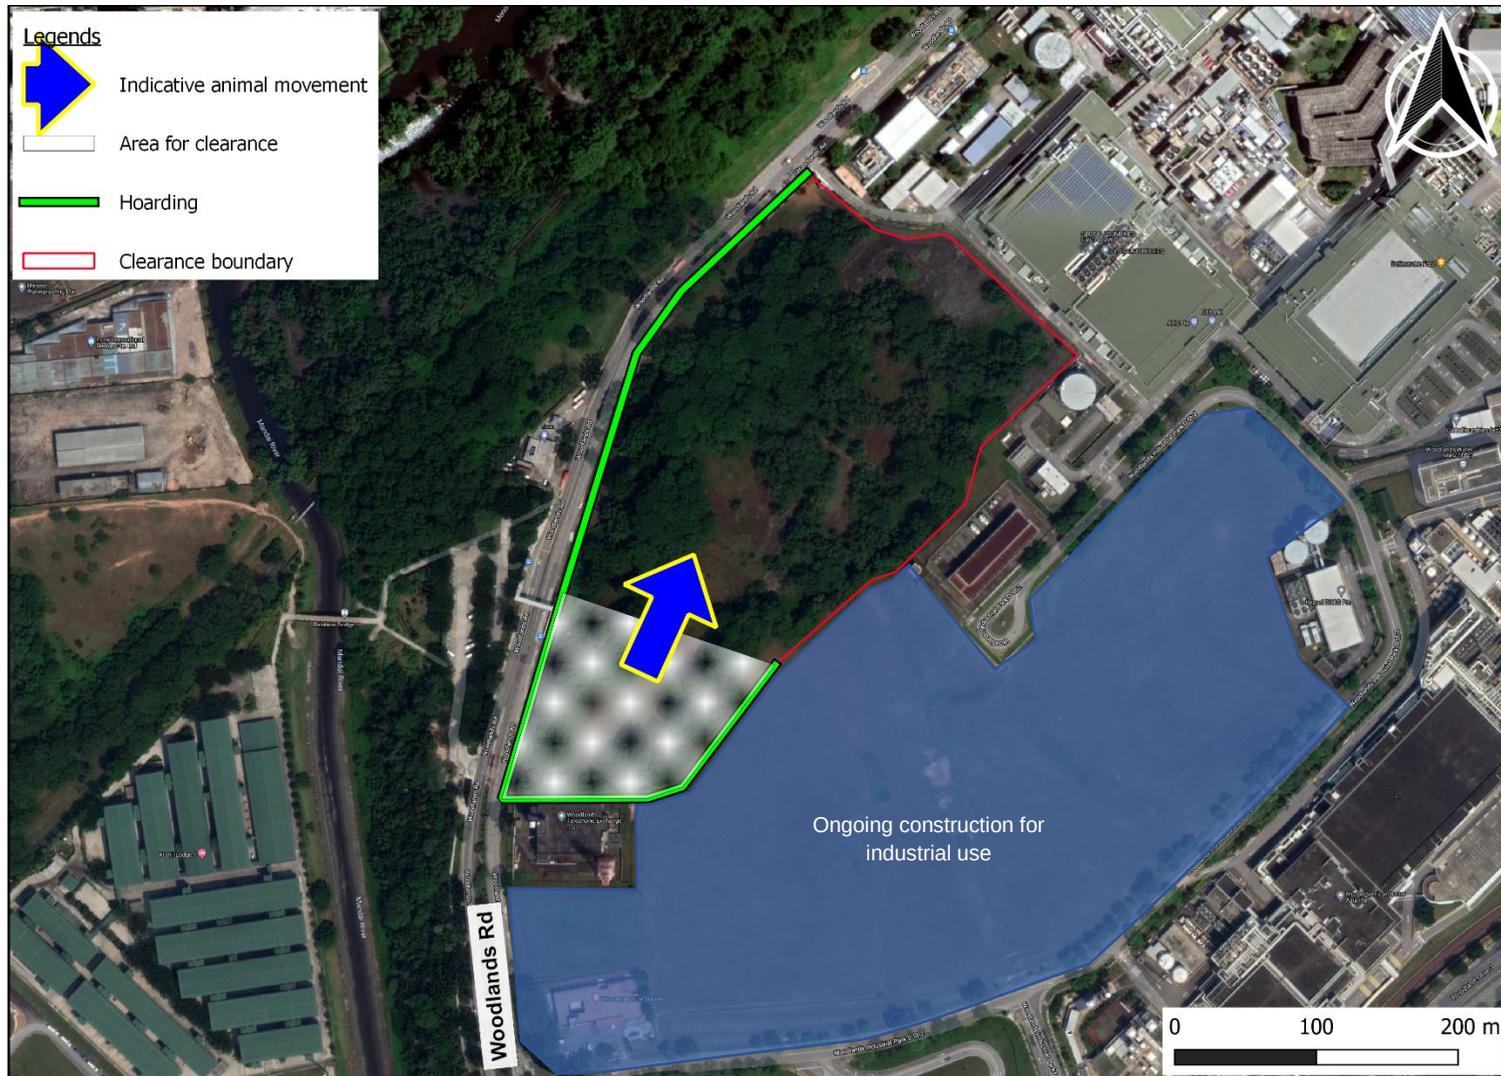
Figure 5.3. Directional Clearance 3

Phase 1 clearance shall then commence, going northward gradually.

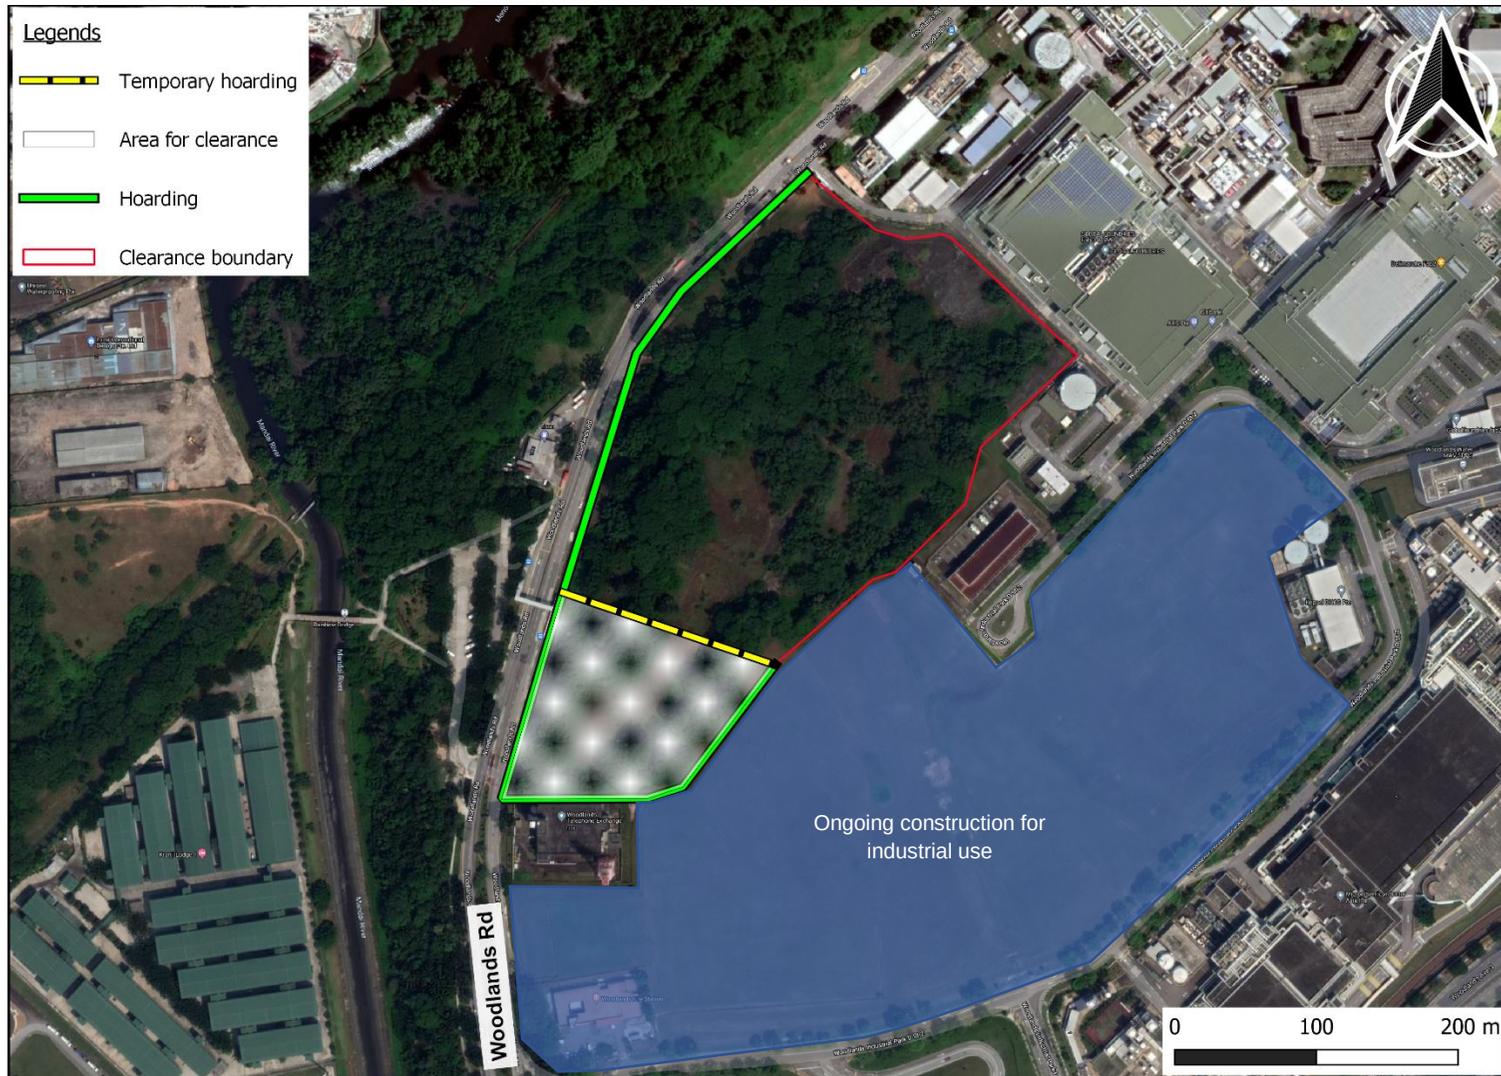
Figure 5.4. Directional Clearance 4

Cleared areas will be temporarily hoarded at the edge to prevent fauna from re-entering cleared areas.

Once understorey vegetation is cleared and trees are about to be felled, all tree holes, nests, and burrows should be recorded and inspected for wildlife presence.

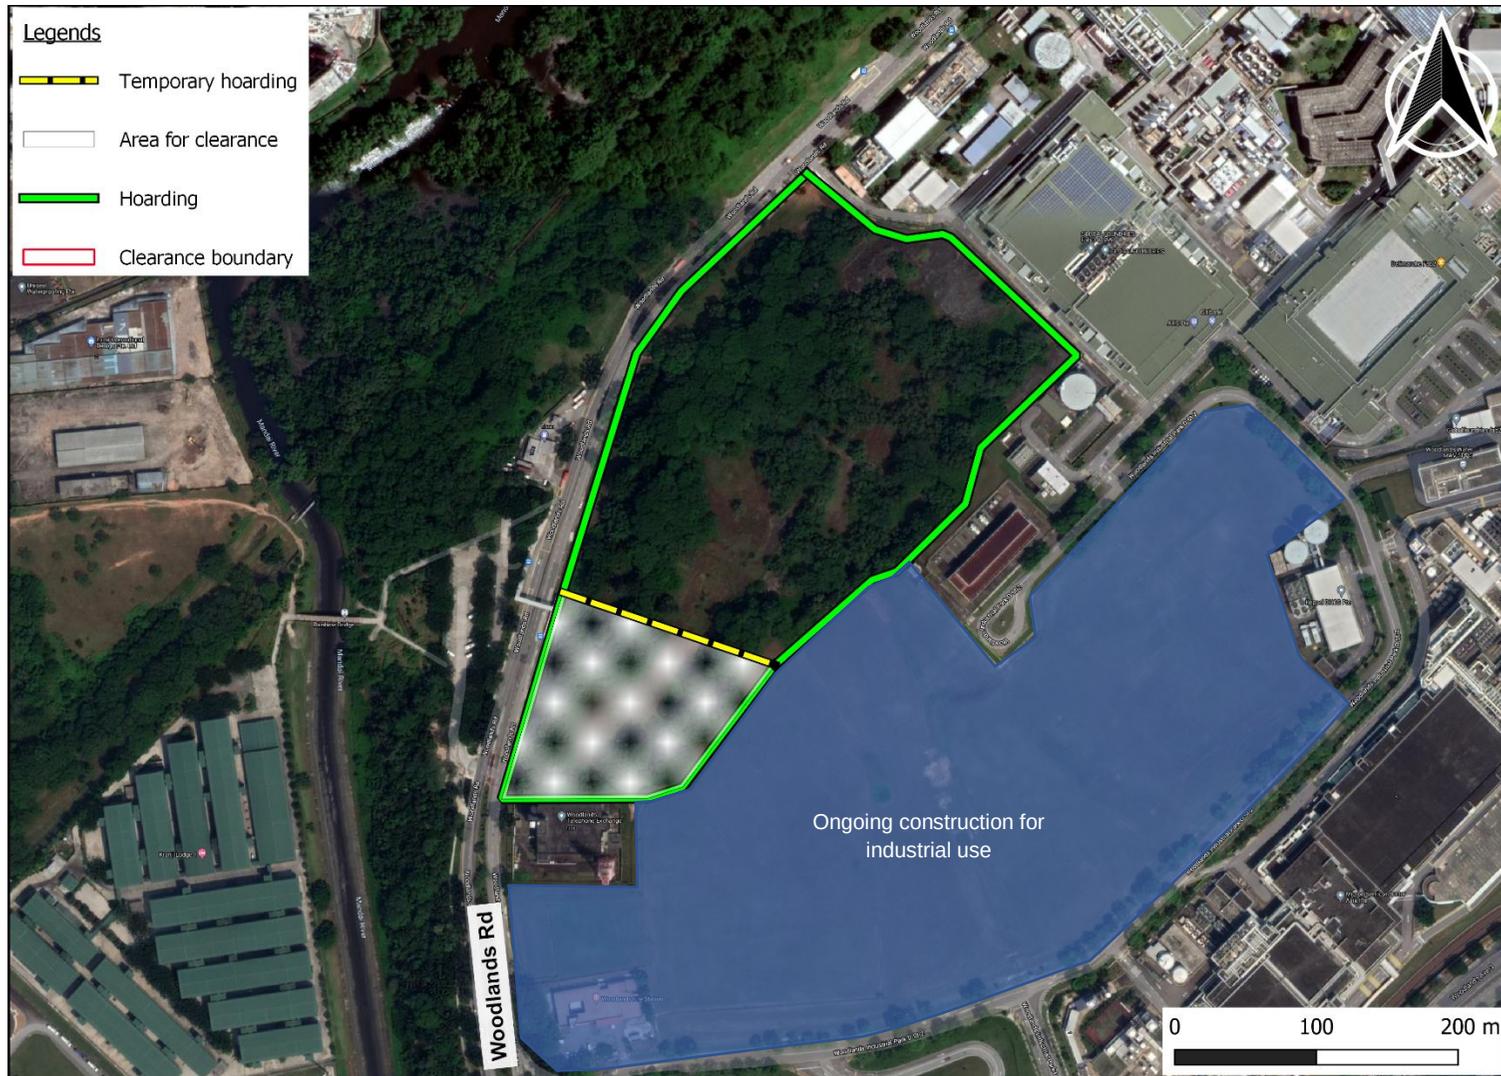
Figure 5.5. Directional Clearance 5

Next, hoarding shall be erected along the rest of the clearance boundary for the Phase 2 clearance.

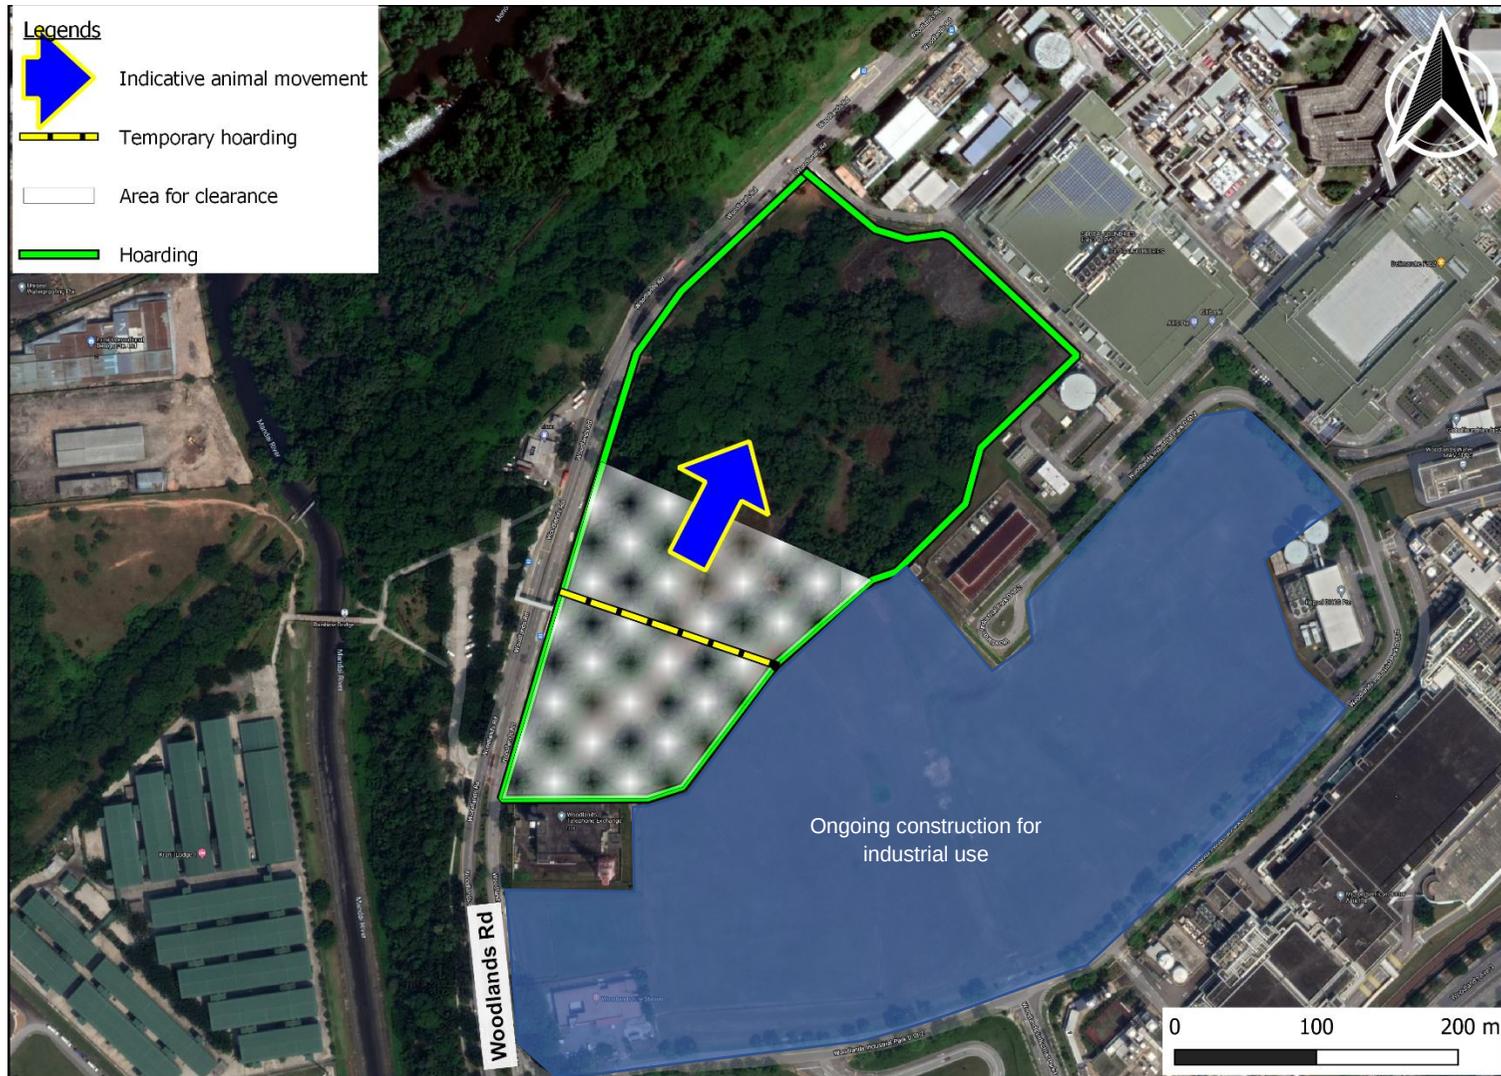
Figure 5.6. Directional Clearance 6

Phase 2 clearance is to be conducted in three stages, beginning with the first one-third immediately adjacent to Phase 1 clearance area.

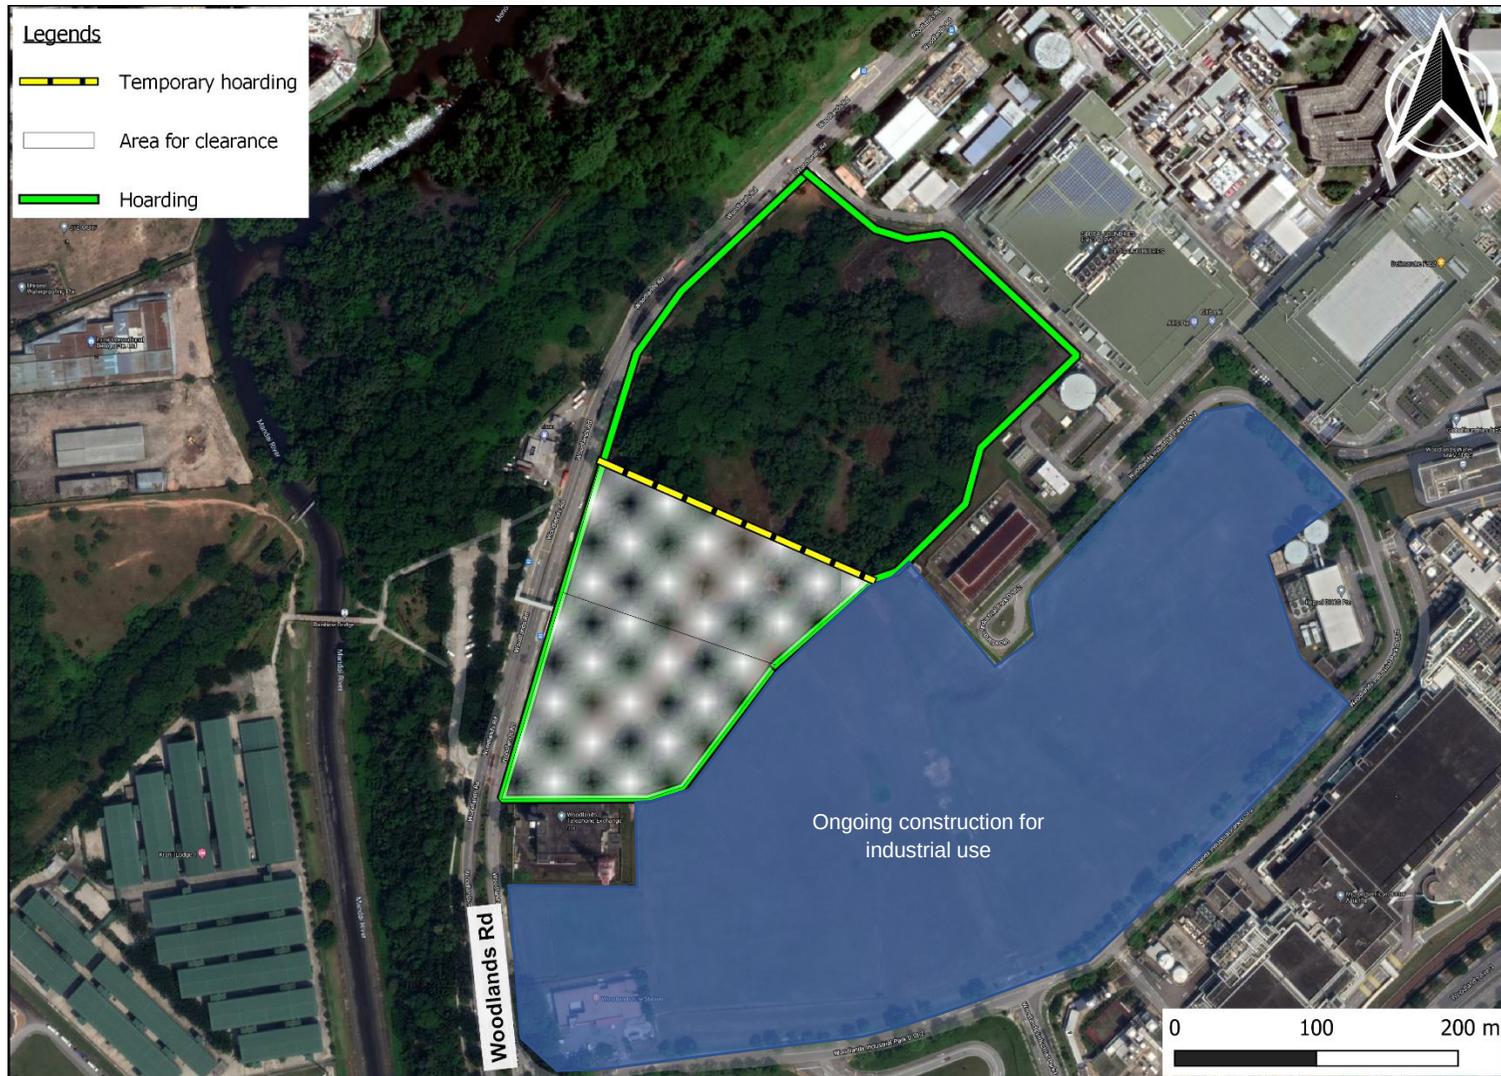
Figure 5.7. Directional Clearance 7

Cleared areas will be temporarily hoarded at the edge to prevent fauna from re-entering cleared areas.

Once understorey vegetation is cleared and trees are about to be felled, all tree holes, nests, and burrows should be recorded and inspected for wildlife presence.

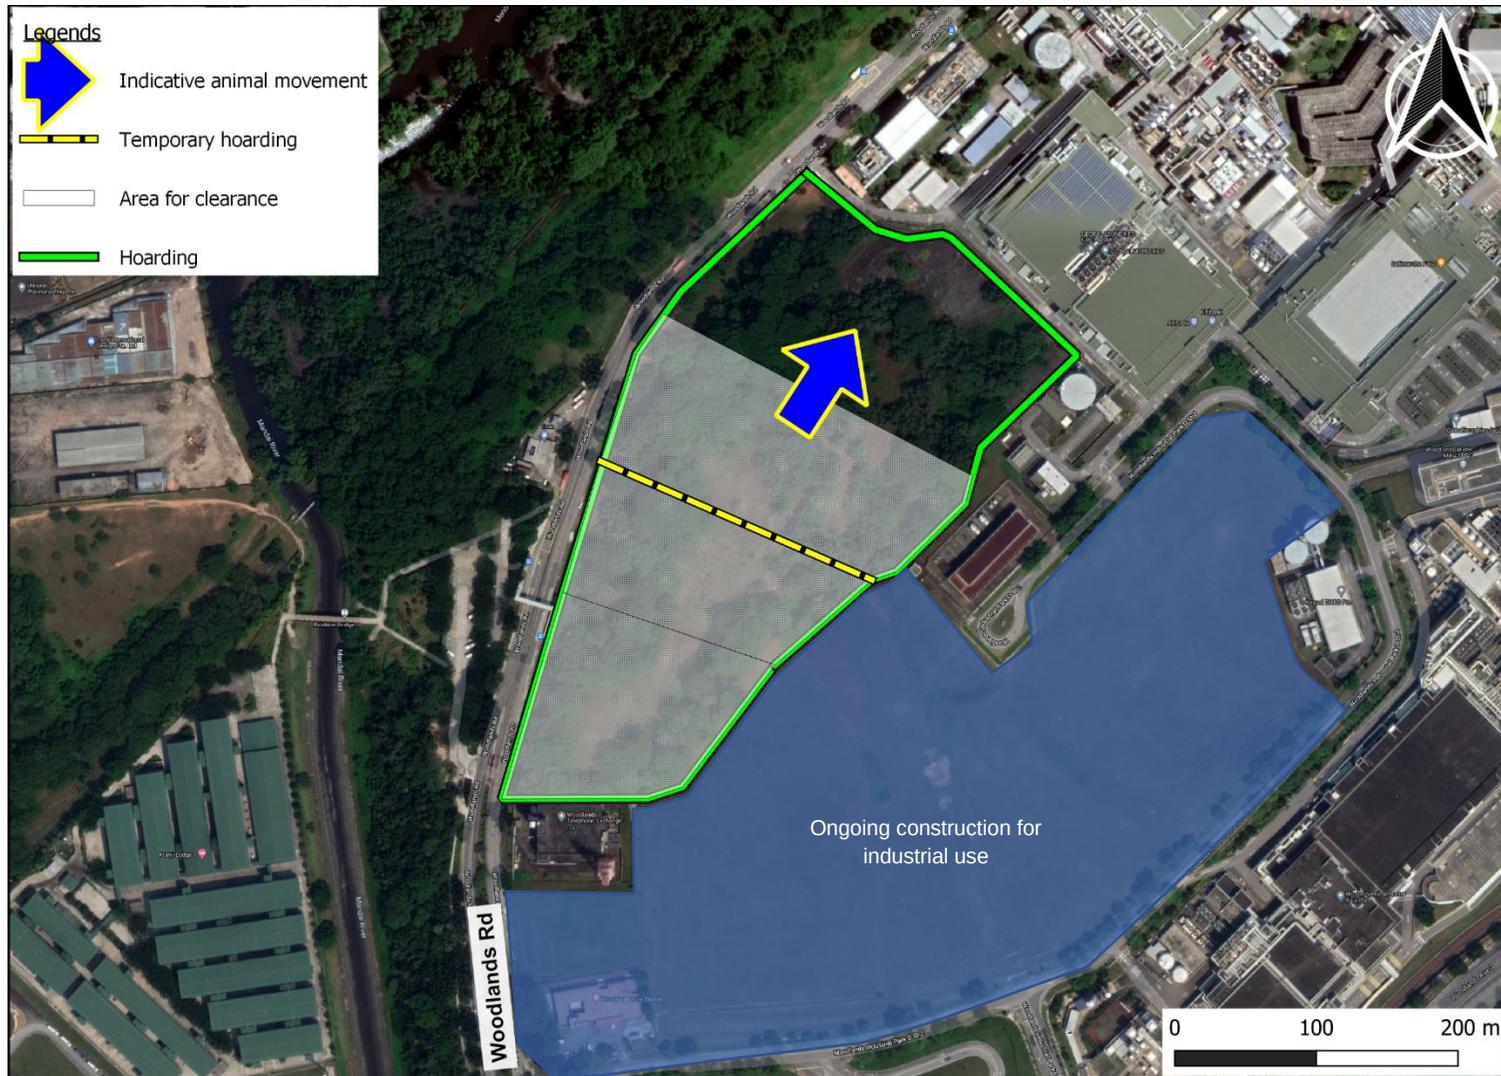
Figure 5.8. Directional Clearance 8

The second one - third of Phase 2 clearance is to be conducted next.

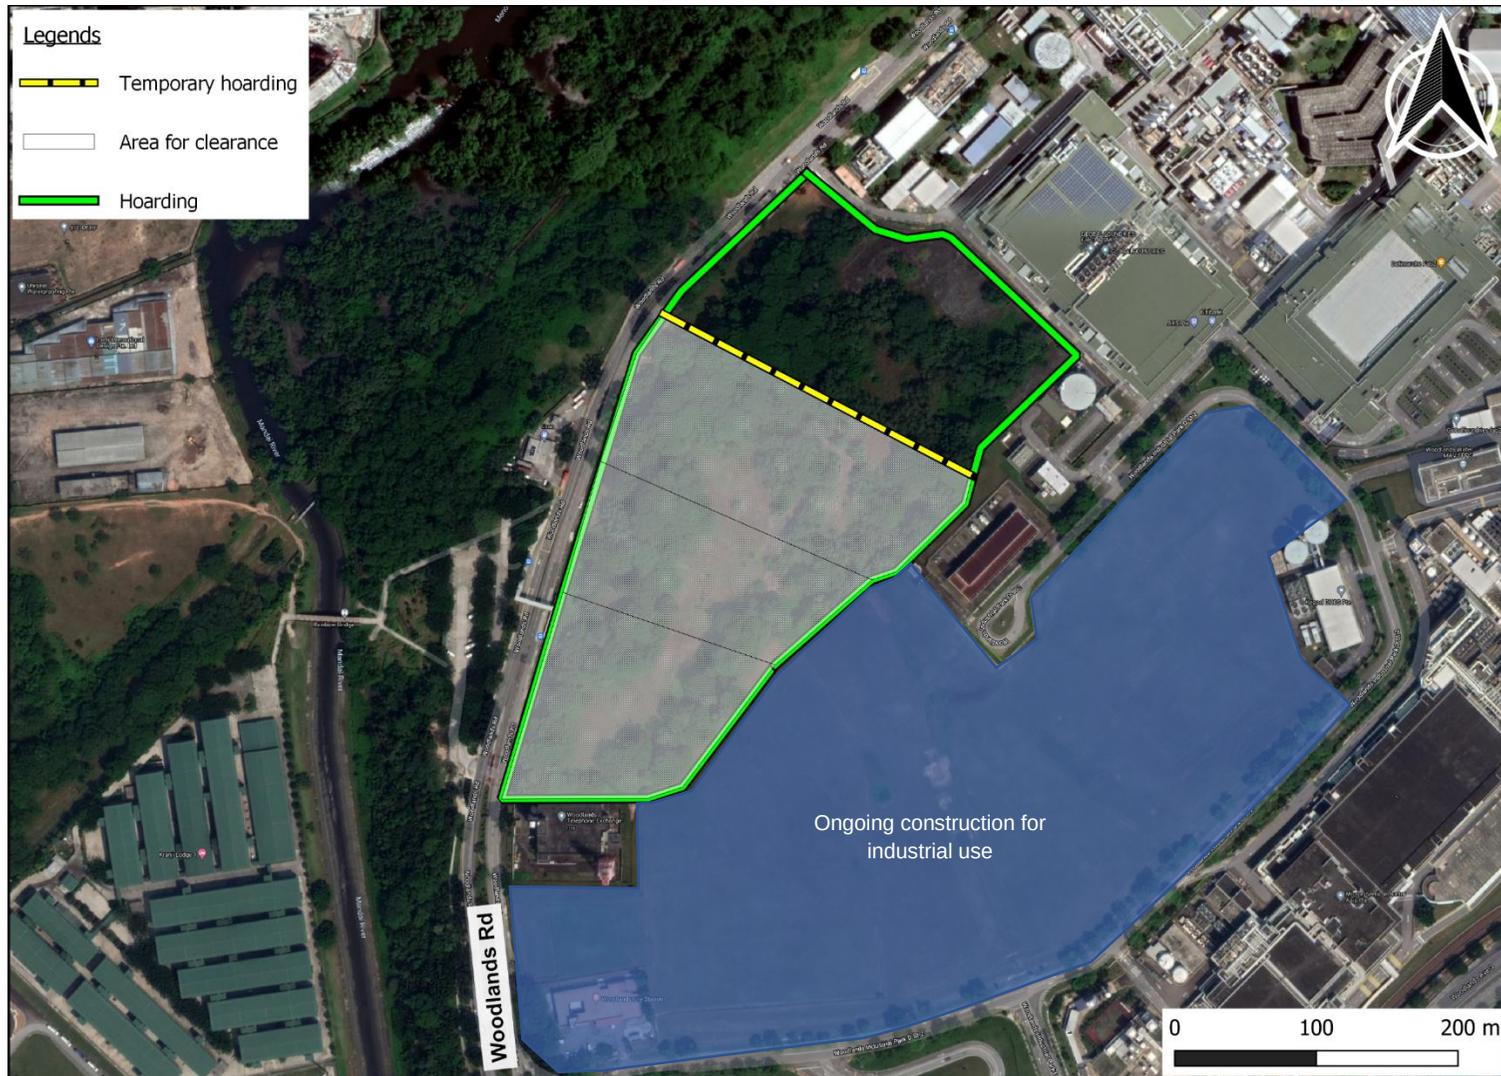
Figure 5.9. Directional Clearance 9

Cleared areas will be temporarily hoarded at the edge to prevent fauna from re-entering cleared areas.

Once understorey vegetation is cleared and trees are about to be felled, all tree holes, nests, and burrows should be recorded and inspected for wildlife presence.

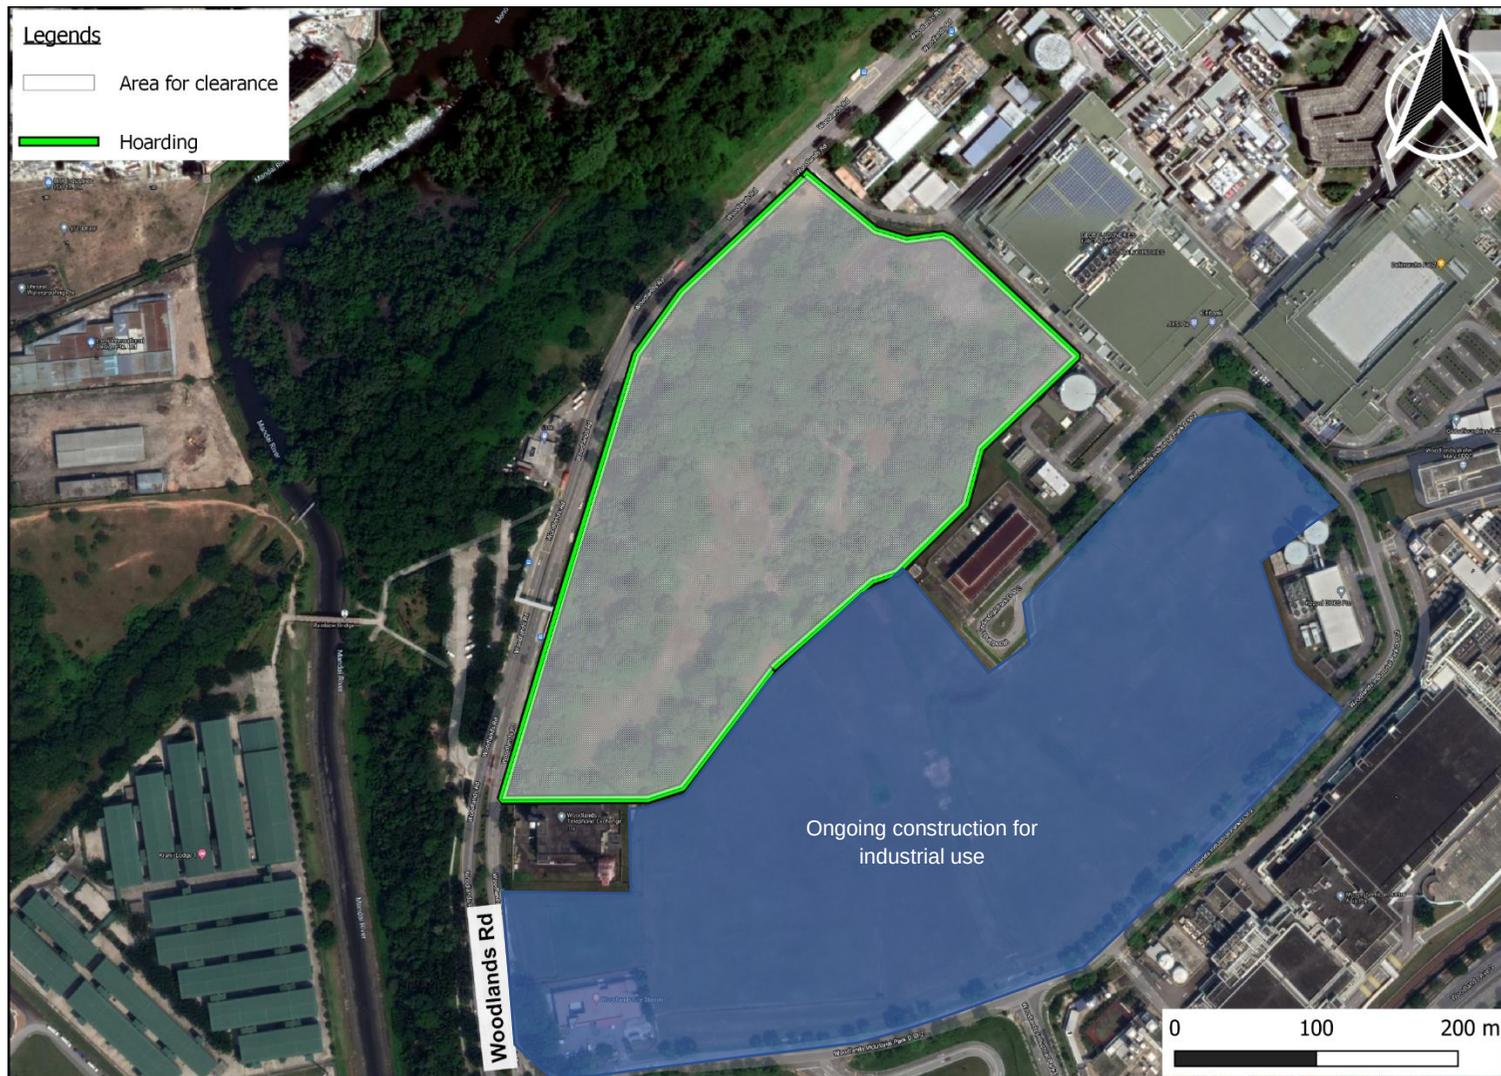
The final one-third of Phase 2 clearance is to be conducted next.

Upon completion of clearance, temporary hoardings can be removed.
