1 3D AXOMETRIC VIEW 01

| SK Number | C-SK 0457-1 |
| Project No. | 230_PDD |

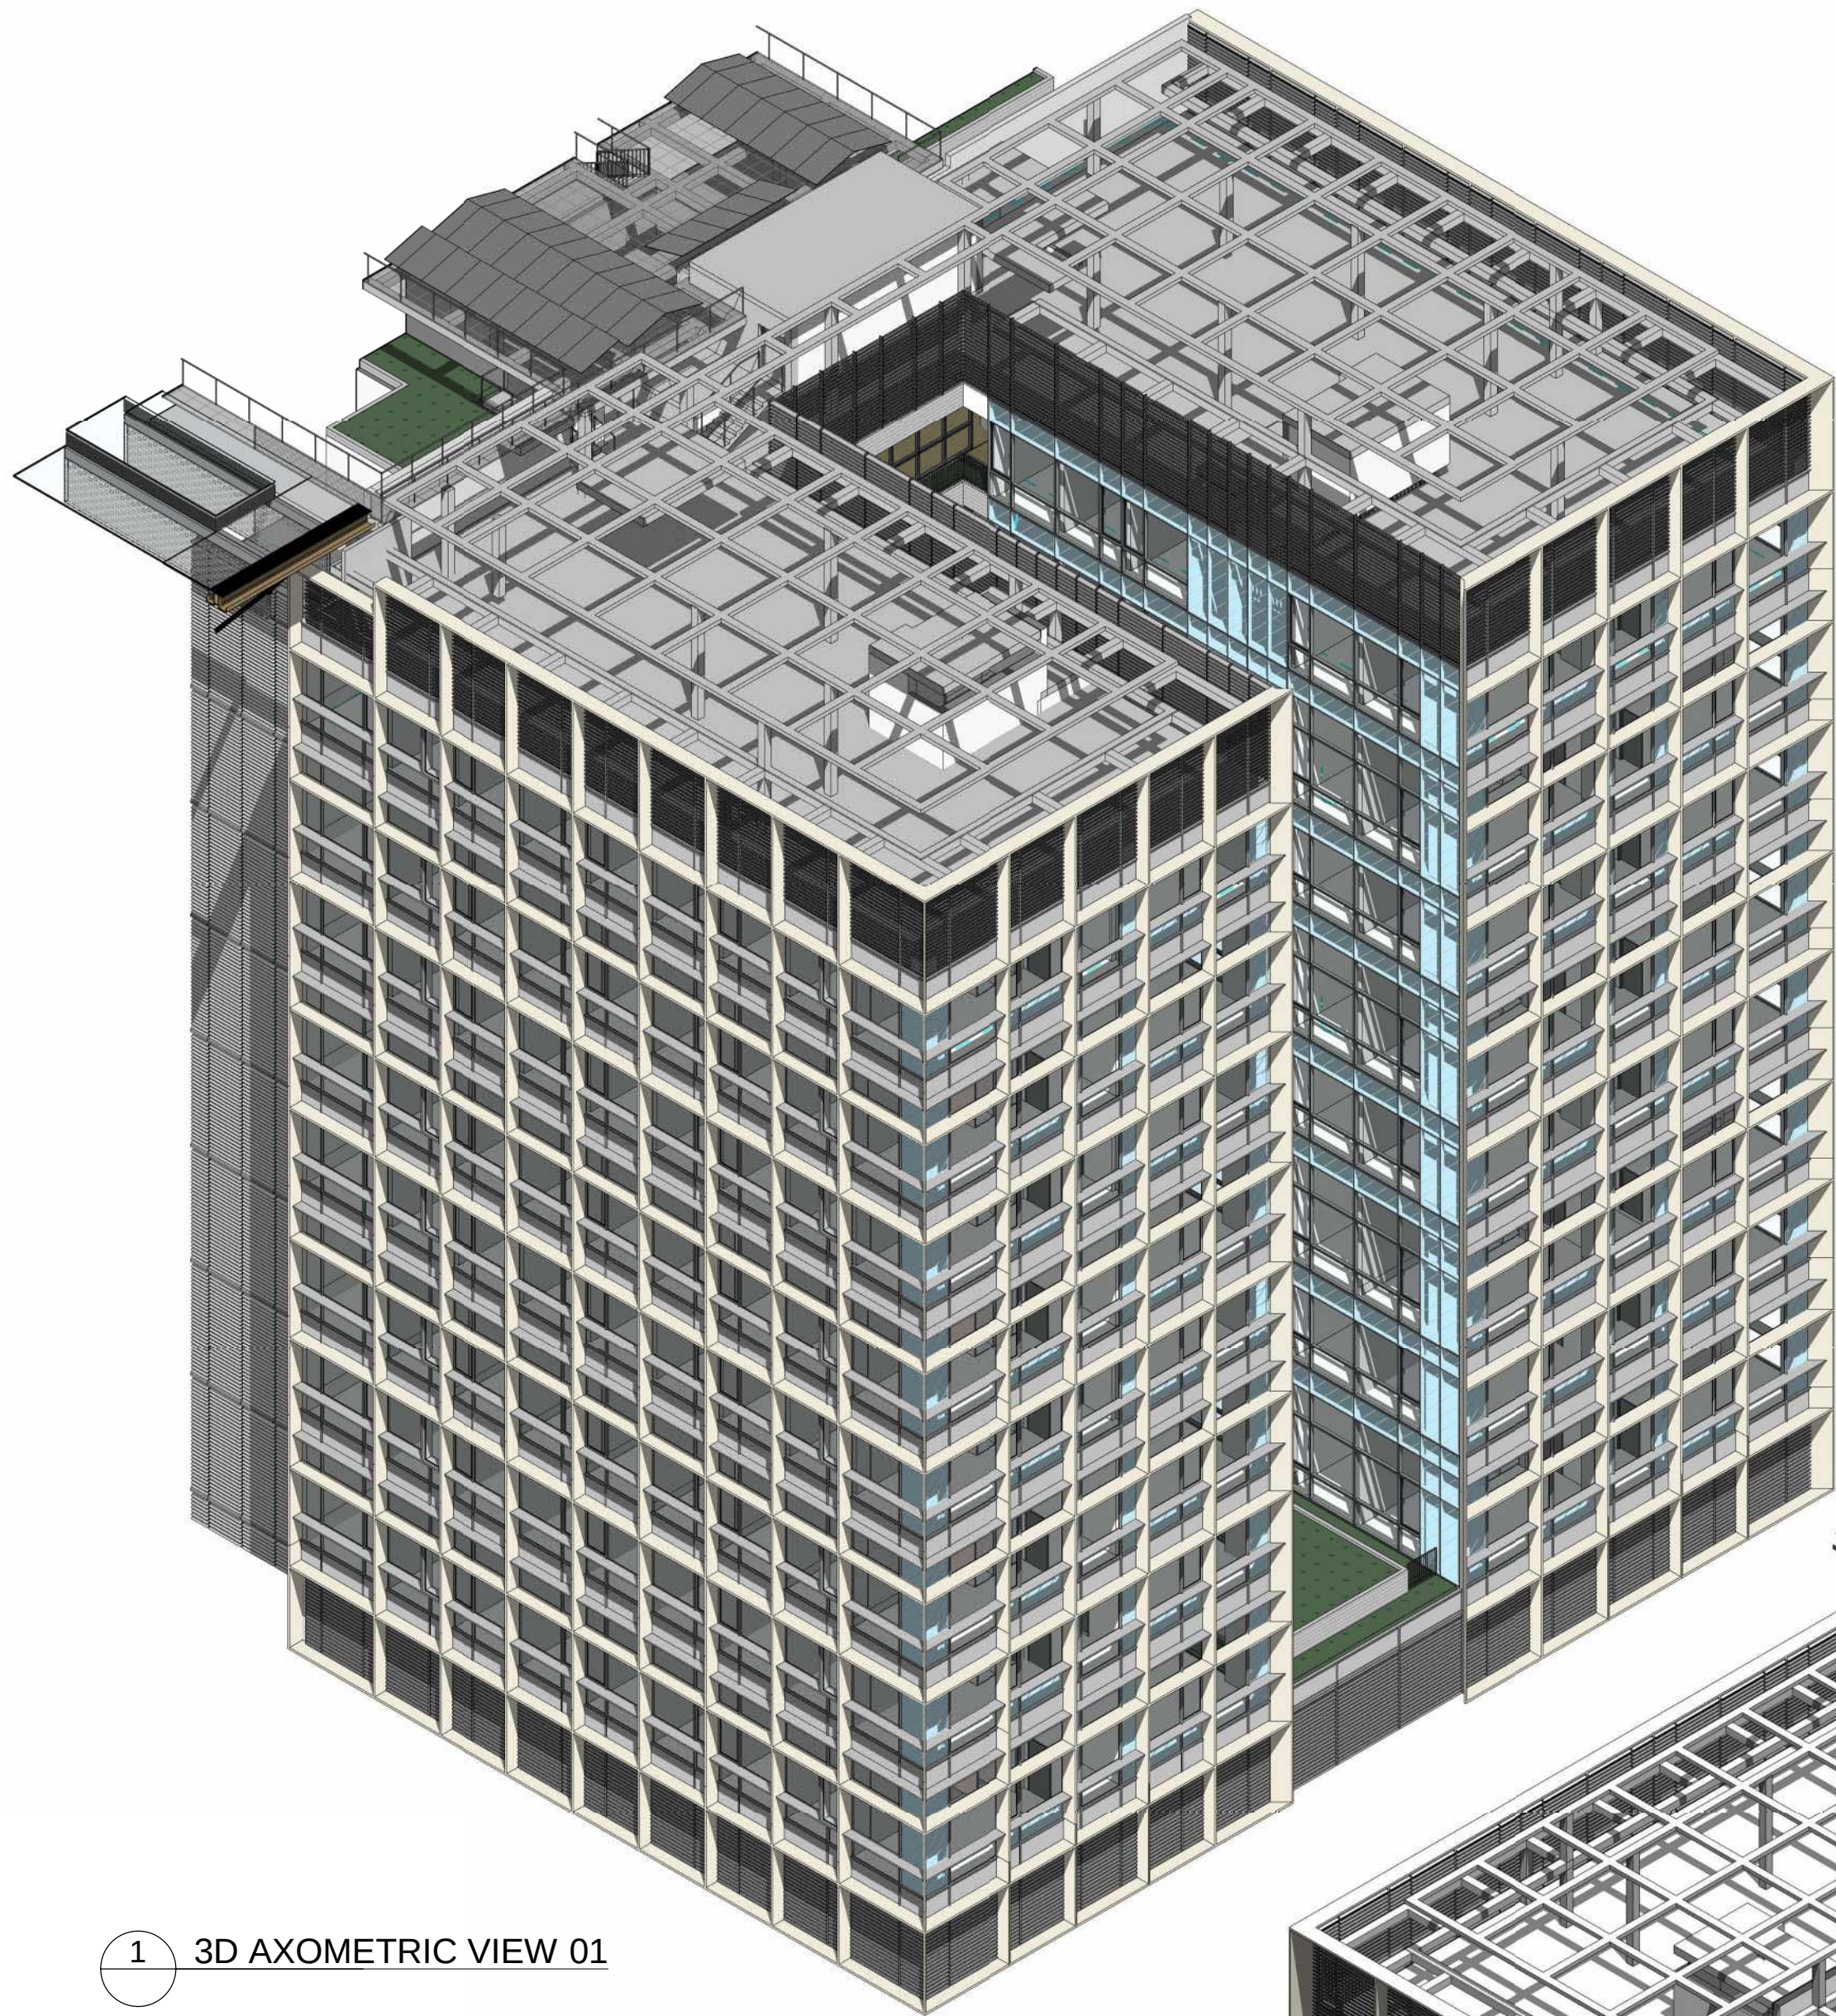
Powder coated aluminum  
fins

Double glazing unit glass  
system

Reinforced concrete planter with  
stainless steel railings

Double Glazing Unit glass system

Double Glazing Unit glass with  
insulated aluminum back panel

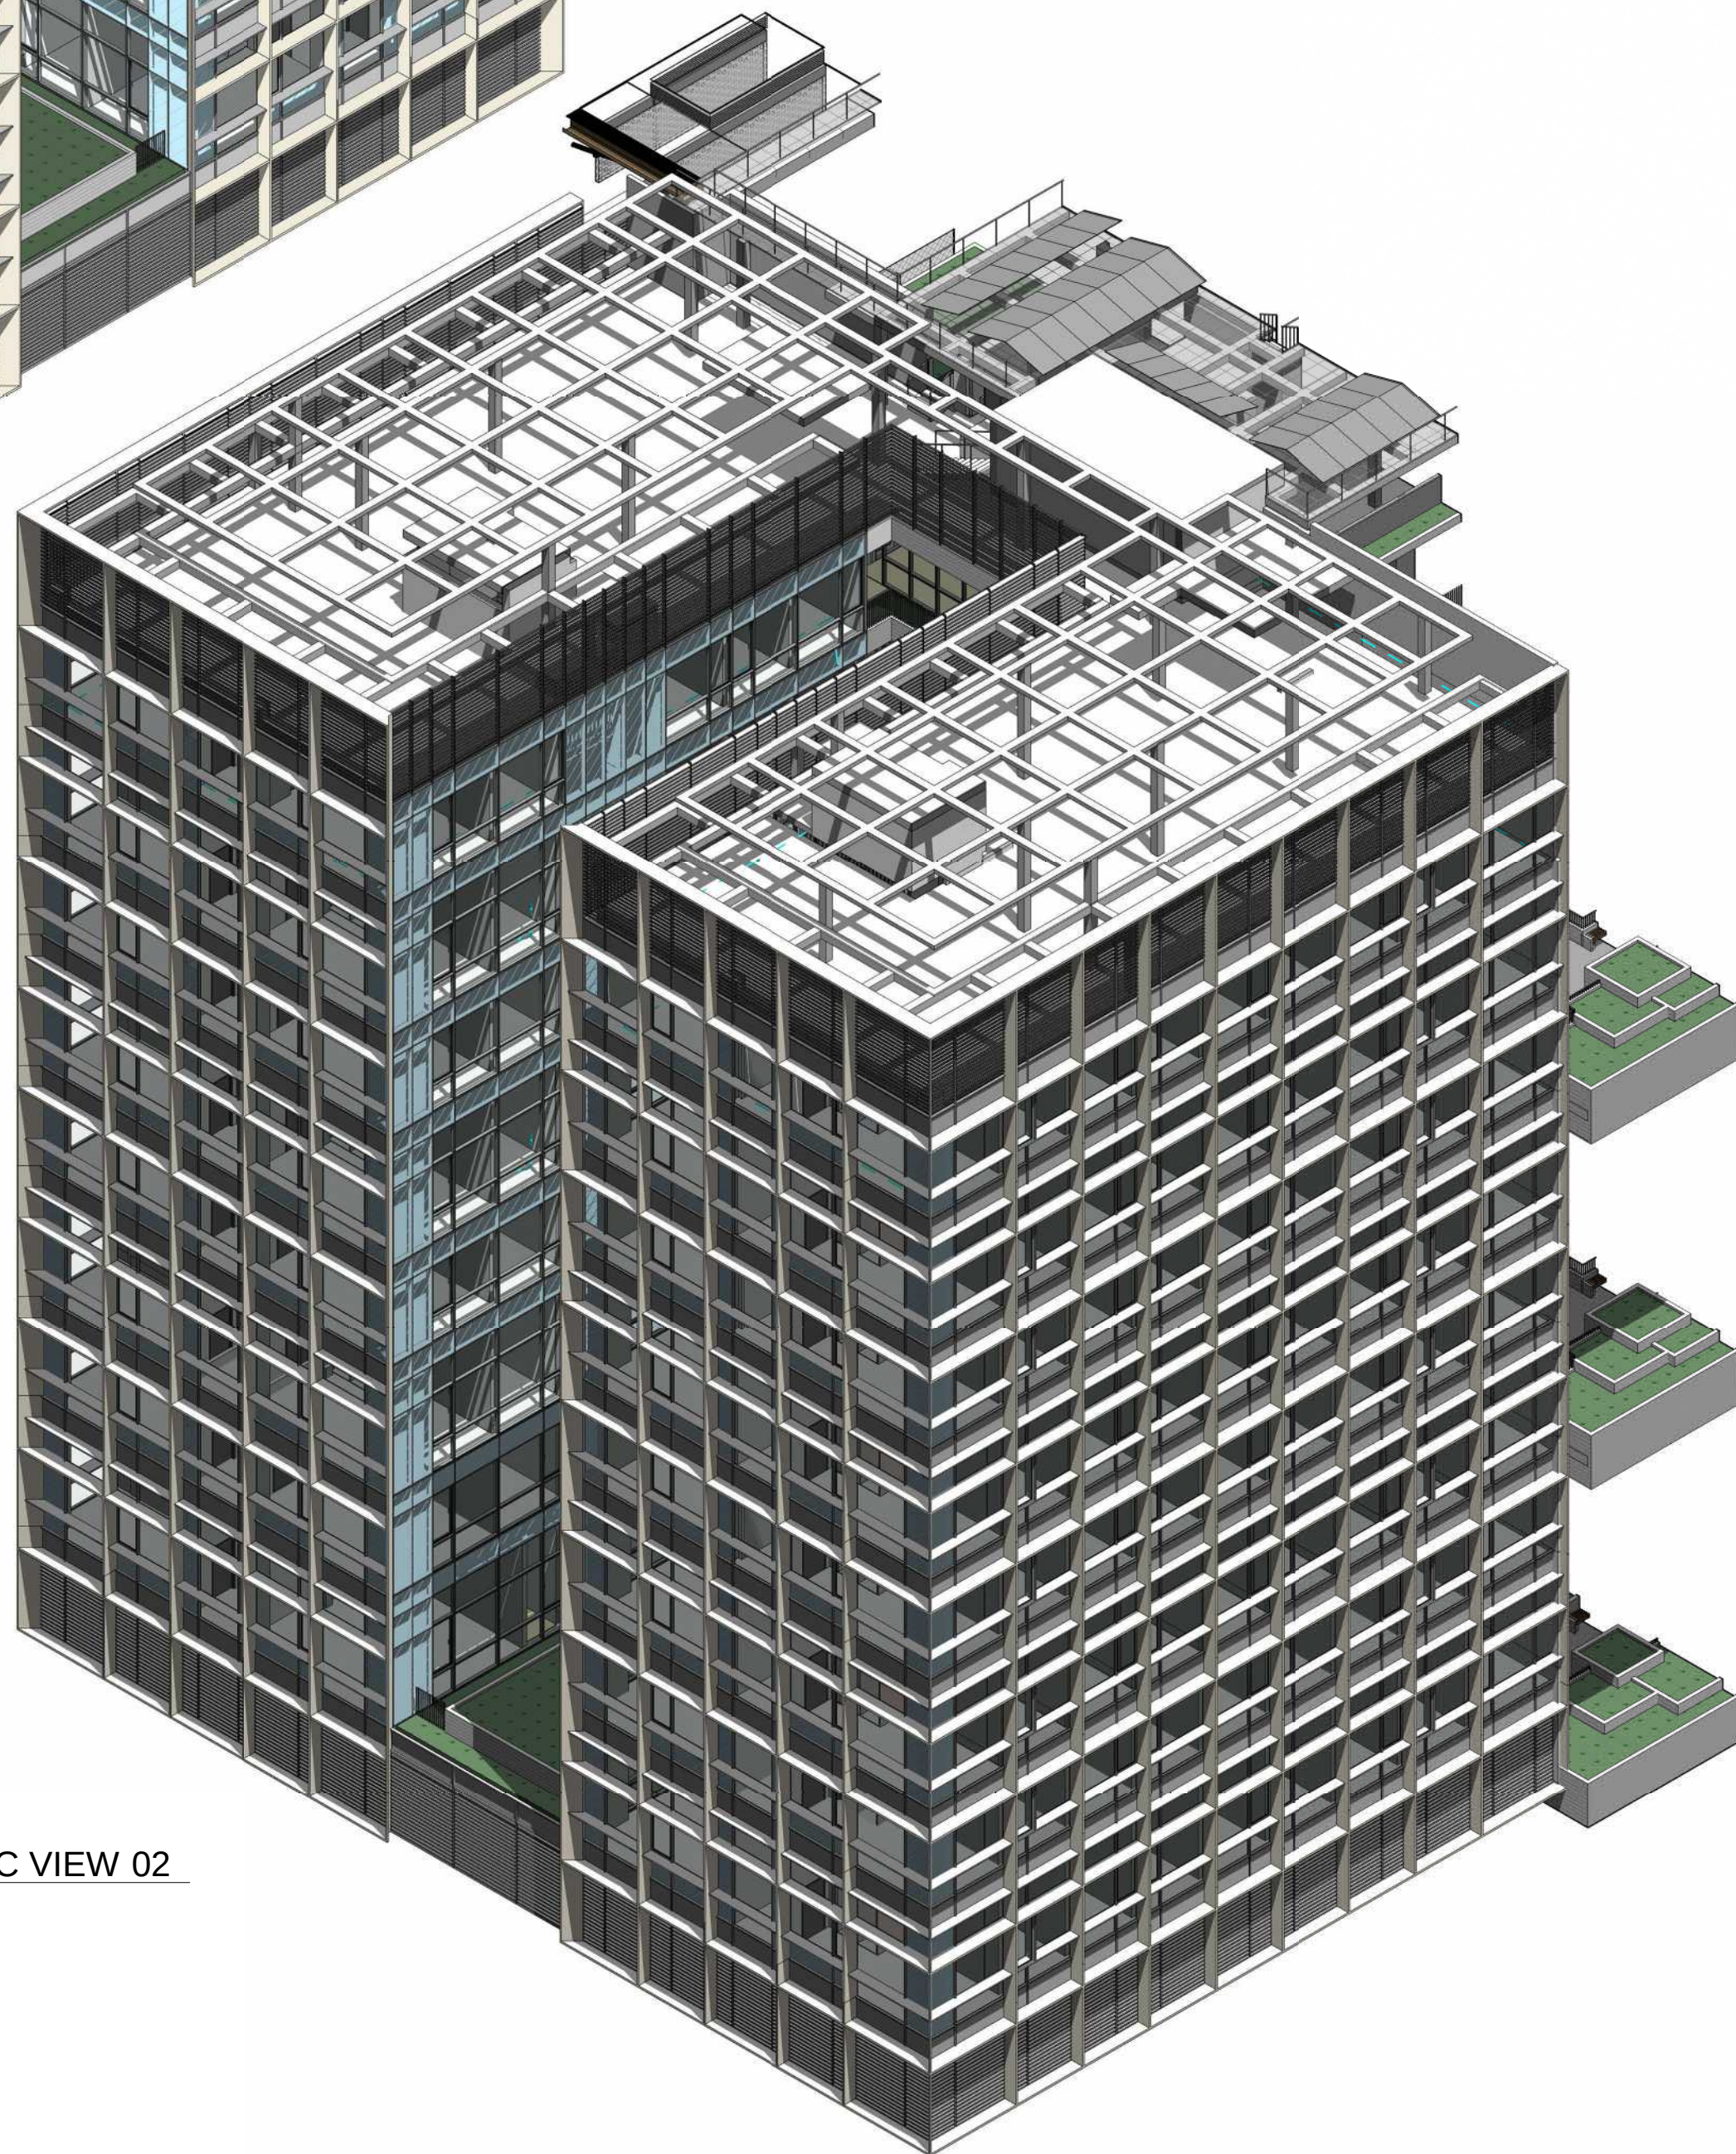
2 3D AXOMETRIC VIEW 02

FAP PANEL  
No obstruction to hinder  
fire fighter's access into the  
Hotel units.

Double Glazing Unit glass system

Double Glazing Unit glass with  
insulated aluminum back panel

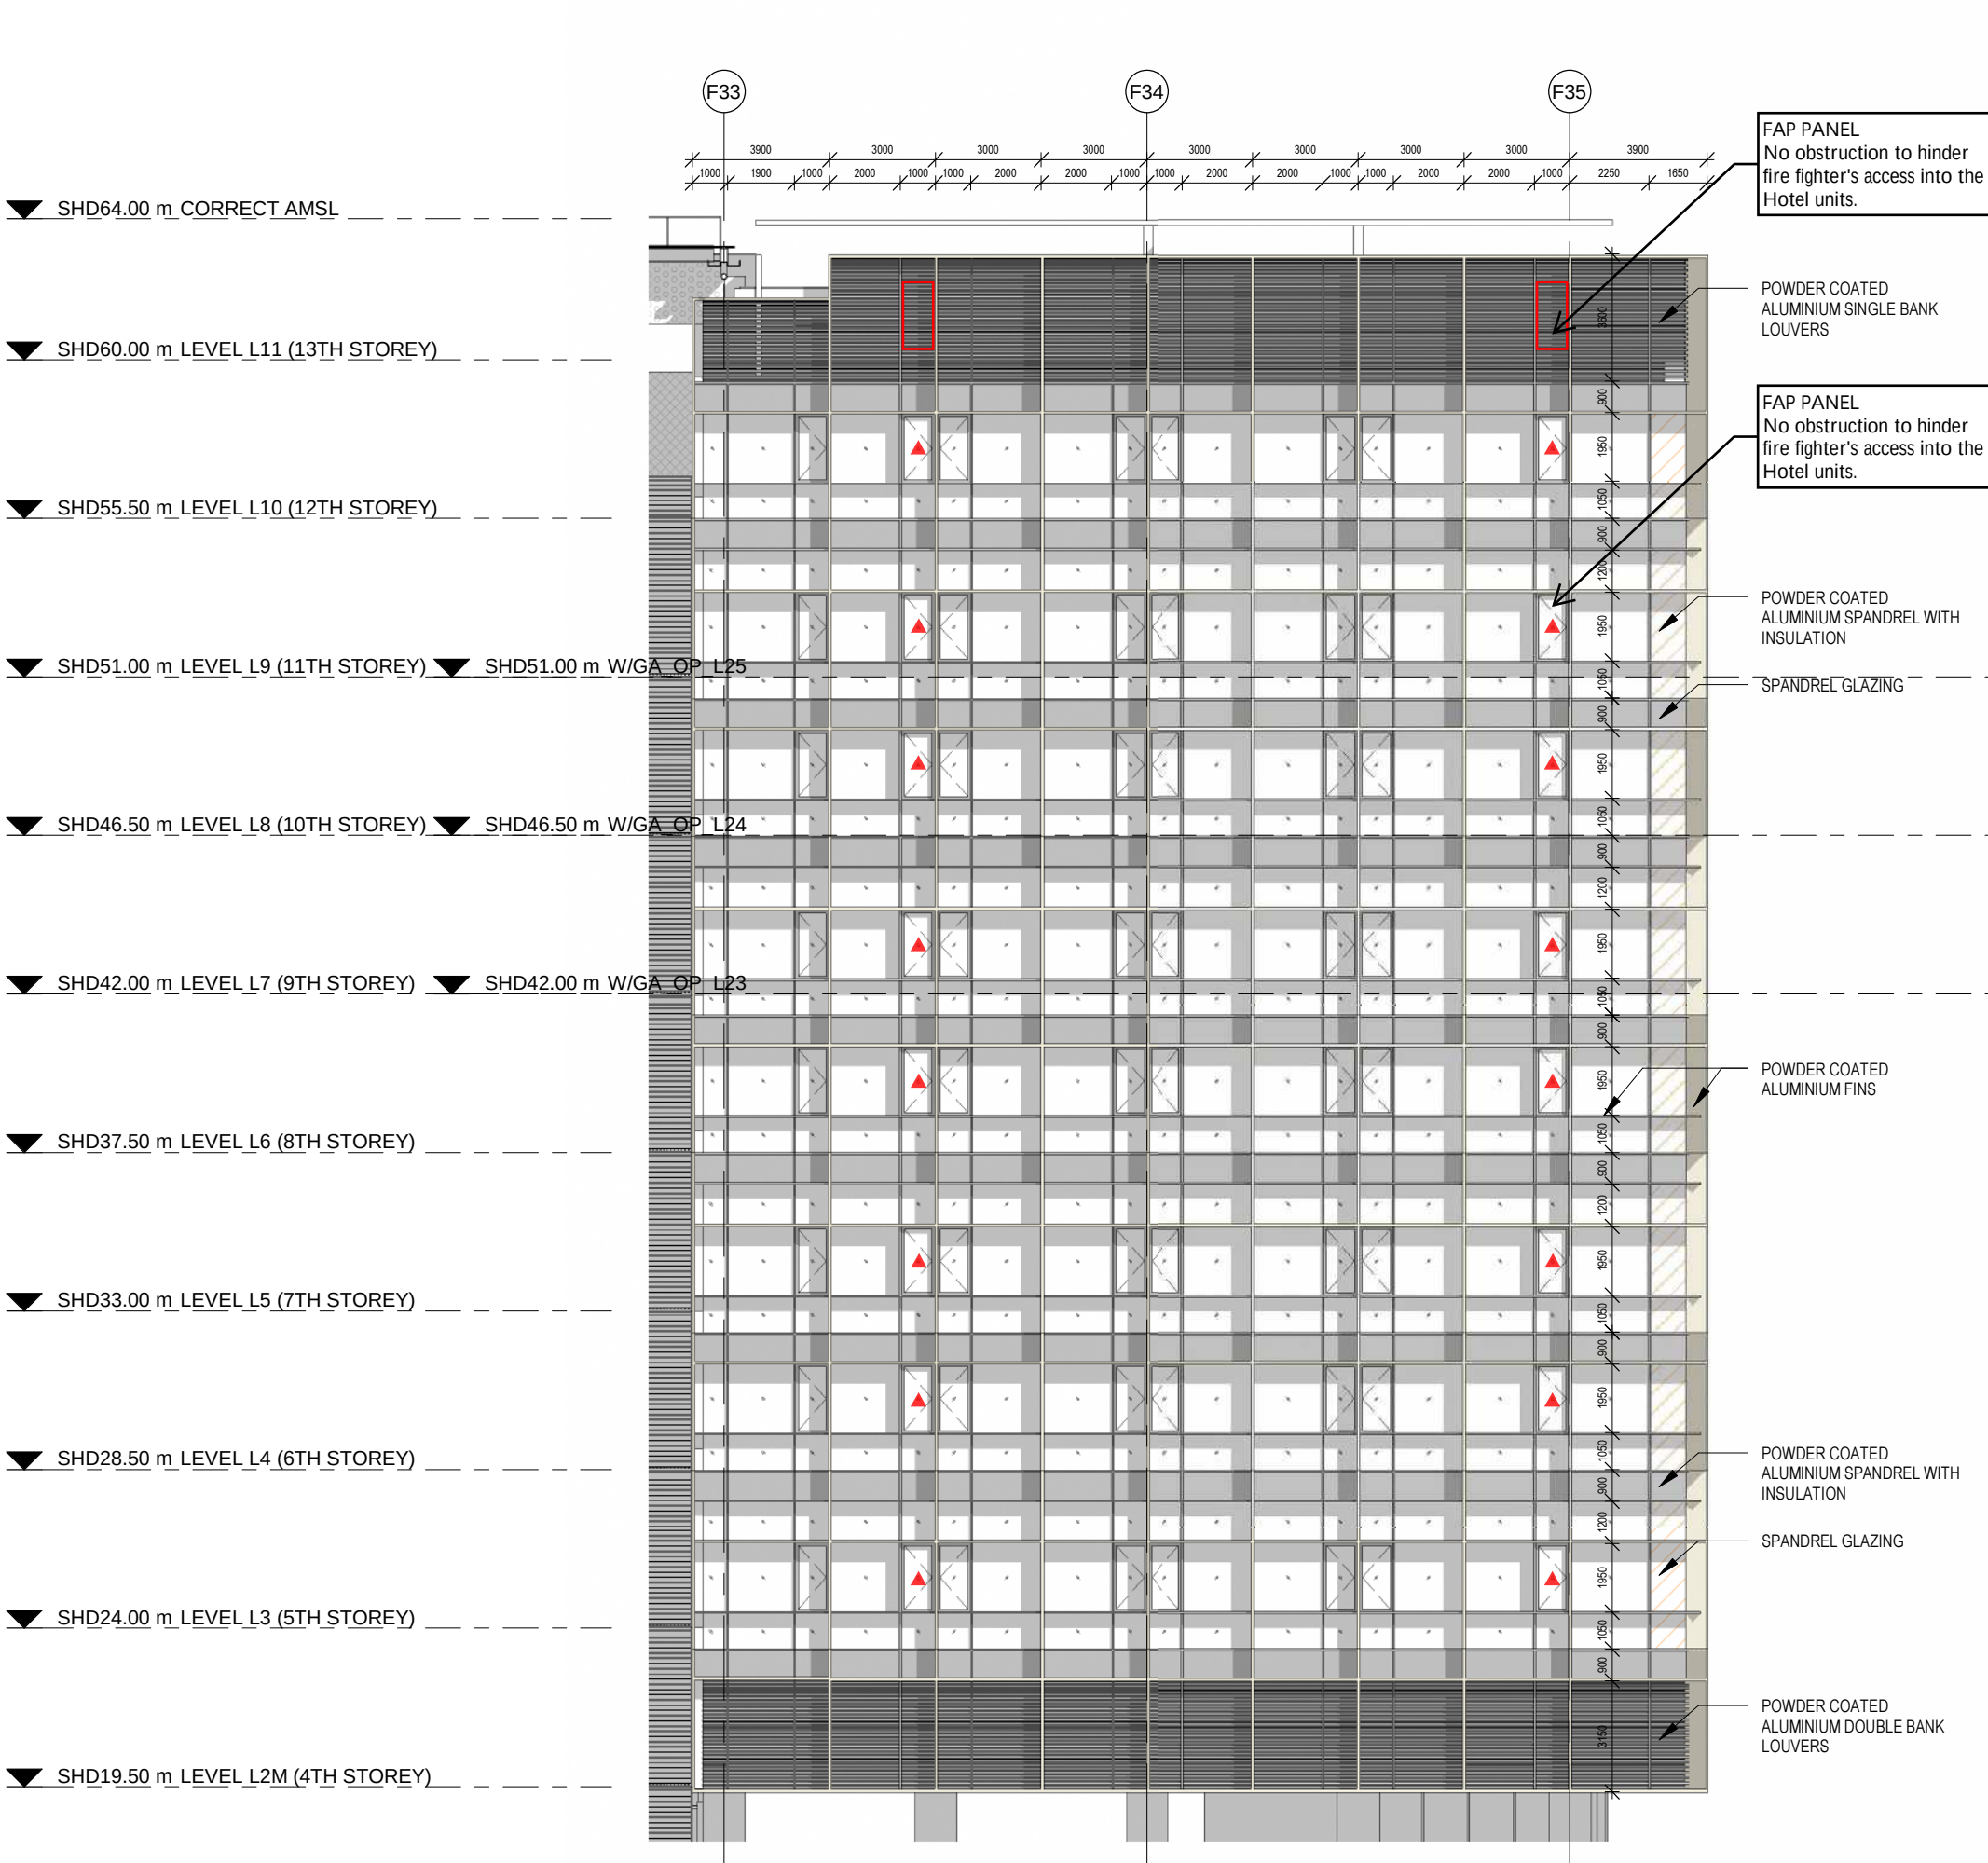
2 SOUTH ELEVATION  
1 : 200

NOTE:  
▲ Fire Access Panel for fire fighting access into the Hotel units.  
There shall be no obstruction at the panel to hinder fire fighter's access into the internal space.
